UPPER FARMINGTON RIVER MANAGEMENT PLAN
FIGURE 15
LOCAL BASIN PERCENT IMPERVIOUS

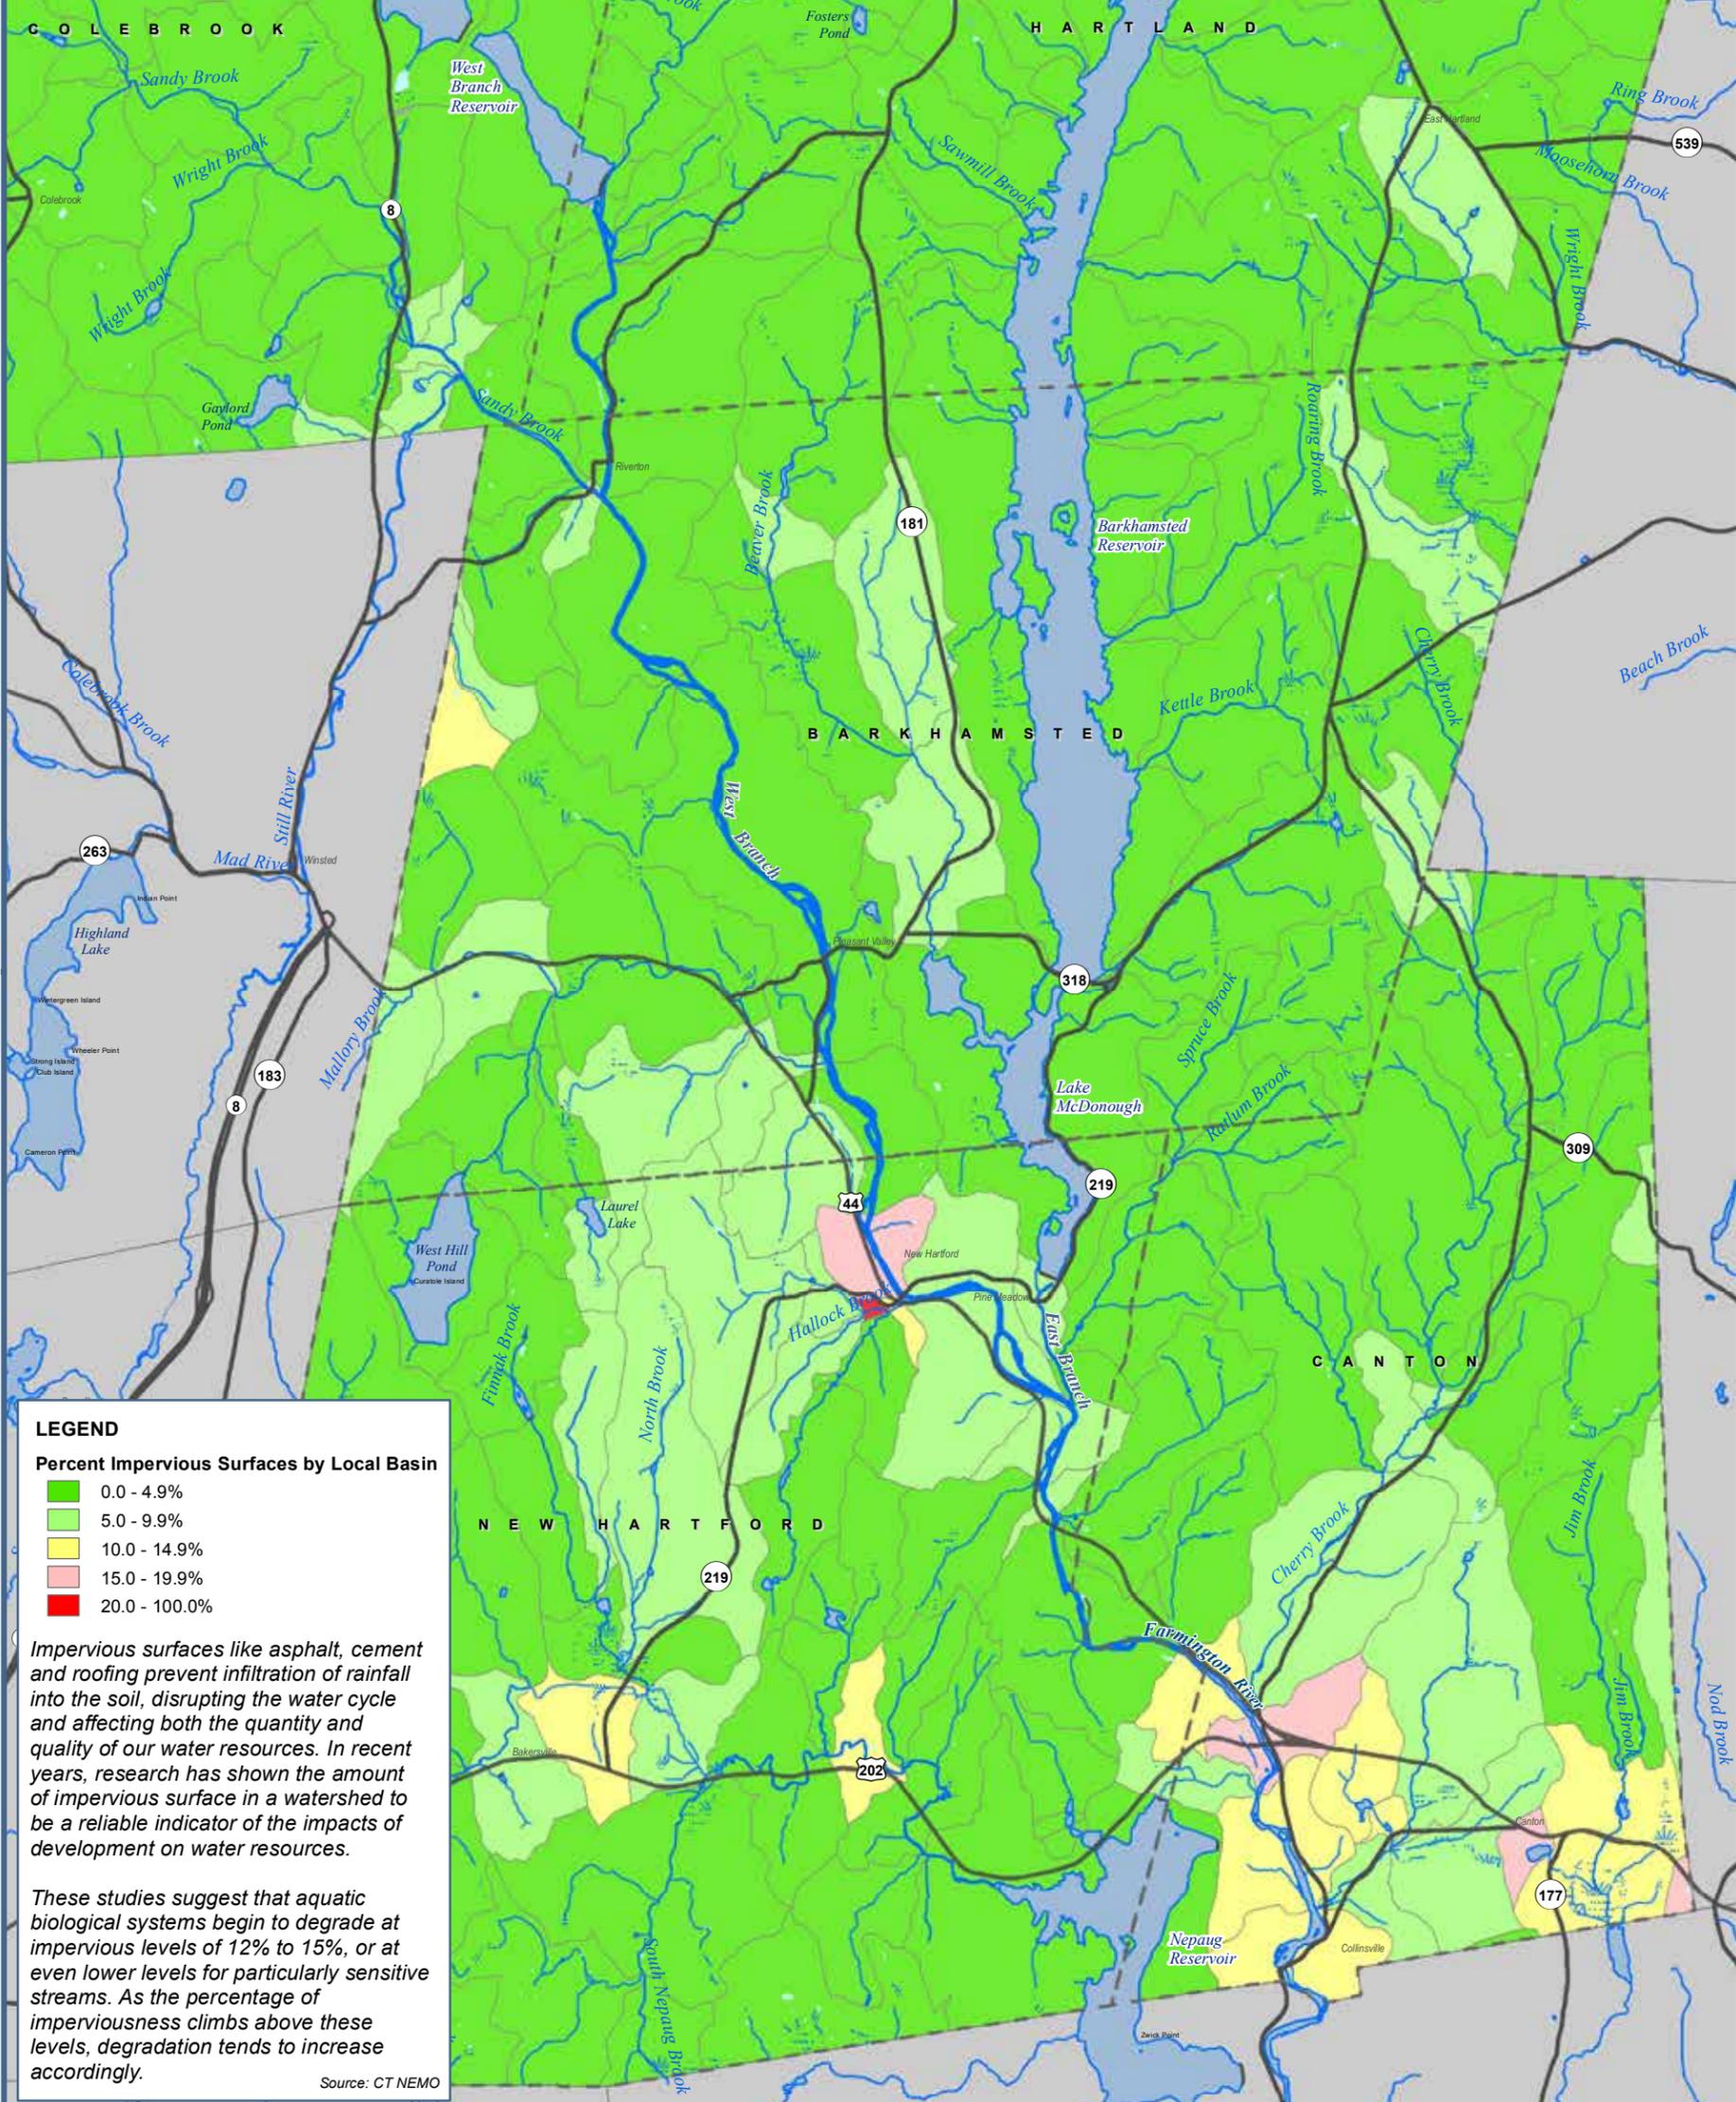
FIGURE 15

Percent Impervious Surfaces by Local Basin

Green	0.0 - 4.9%
Light Green	5.0 - 9.9%
Yellow	10.0 - 14.9%
Pink	15.0 - 19.9%
Red	20.0 - 100.0%

Impervious surfaces like asphalt, cement and roofing prevent infiltration of rainfall into the soil, disrupting the water cycle and affecting both the quantity and quality of our water resources. In recent years, research has shown the amount of impervious surface in a watershed to be a reliable indicator of the impacts of development on water resources.

These studies suggest that aquatic biological systems begin to degrade at impervious levels of 12% to 15%, or at even lower levels for particularly sensitive streams. As the percentage of imperviousness climbs above these levels, degradation tends to increase accordingly.
